Washington State Salmon Recovery Funding Board
**Reach-Scale Effectiveness
Monitoring Program**

2004 Annual Progress Report Preliminary Findings

April 2005

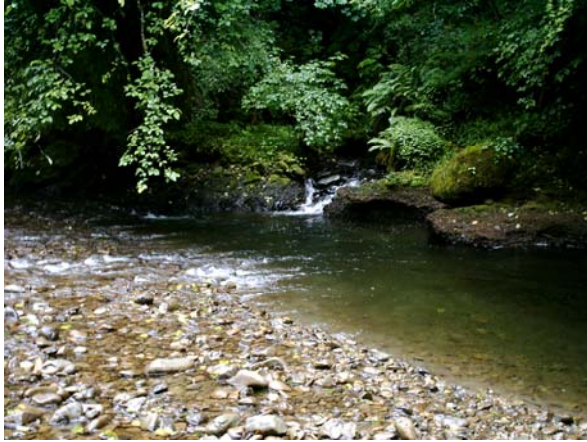
02-1530 Salmon River Tributary 21-0143 Culvert Barrier

Above: confluence of tributary with mainstem Salmon River in control reach

Below: Representative photo of tributary in impact reach

Objective/Intent: This project will replace a 72-inch culvert that is acting as a partial fish barrier on Watershed Resource Inventory Area (WRIA) #21-0143 tributary, 110 feet above the Middle Fork Salmon River confluence. The existing culvert has a 4.5-foot outfall drop and high velocities, creating a partial barrier to

adult salmon migration and a full barrier to juvenile passage. Replacement with an adequately sized arch culvert will provide access to 0.8 miles of spawning and rearing habitat for coho salmon, steelhead, and cutthroat trout.

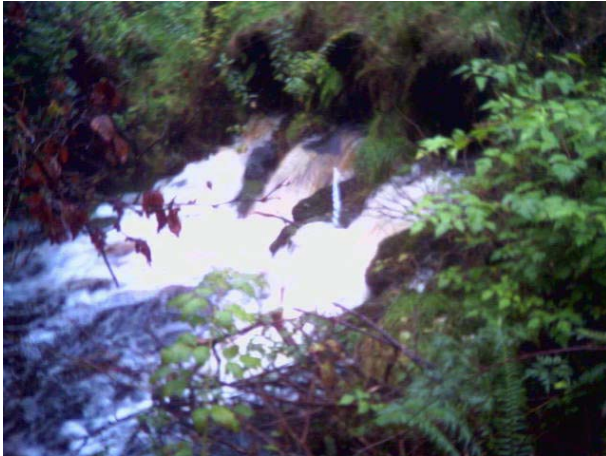
02-1602 Donkey Creek Culvert

Above: Downstream end of triple-barrel culvert during autumn flows

Objective/Intent: Replace known fish barrier culvert on Donkey Creek, opening up 1,200 square meters of spawning habitat and close to 3,000 square meters of rearing area for coho salmon, chum salmon, cutthroat trout, steelhead, and Dolly Varden/bull trout.

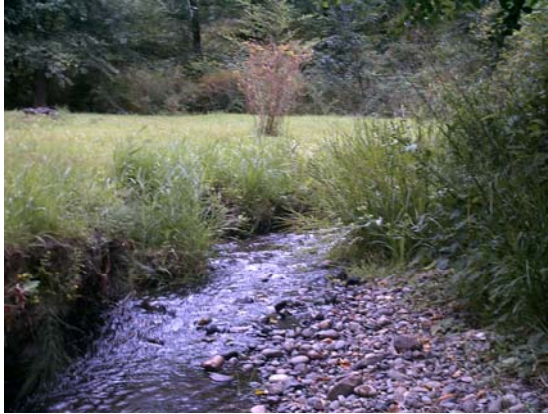
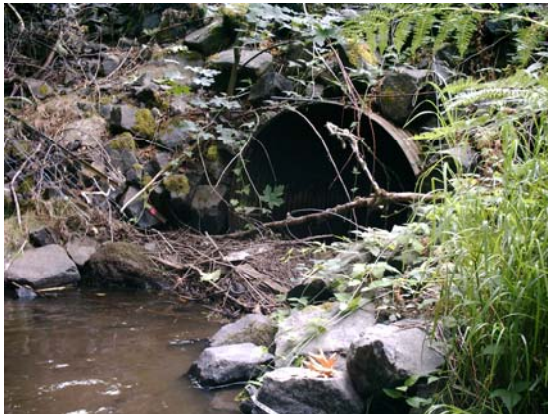
02-1574 Melaney Creek Fish Passage Project

Above: Control reach looking upstream at midpoint
Below: Impact reach looking at the culvert

Objective/Intent: The intent of this project is to improve the road/stream crossing at Agate Road for anadromous and resident fish by replacement of a fish-barrier culvert with a stream simulation structure that will provide

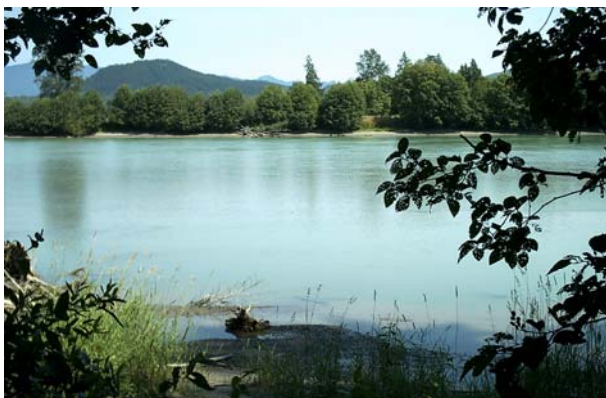
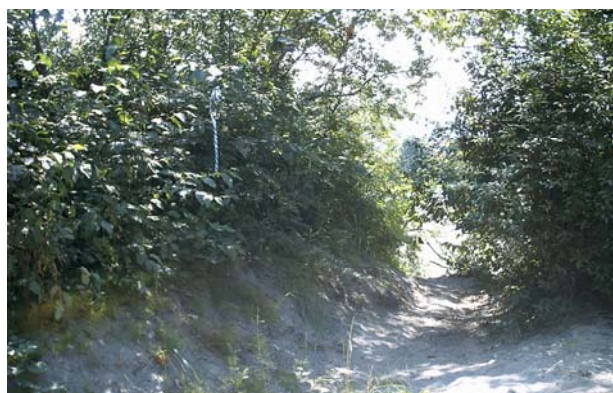
02-1561 Edgewater Park Off-Channel Restoration

Above: Upstream confluence of control site side channel

Below: Dry channel at impact reach

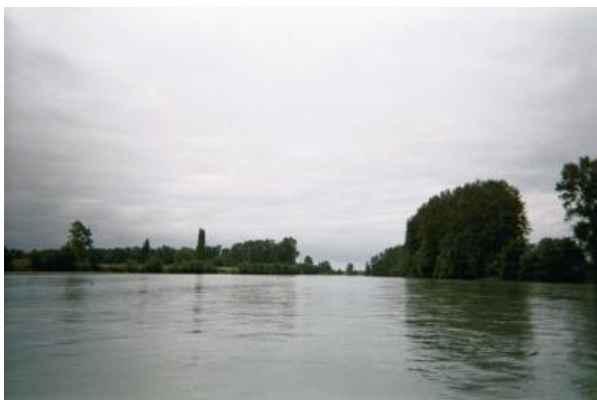
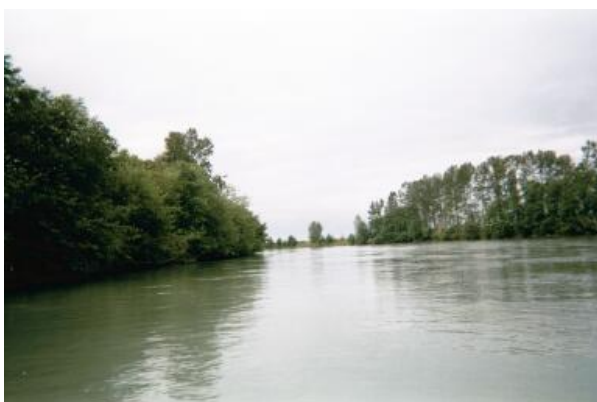
02-1625 South Fork Skagit Levee Setback and Acquisition

Above: Impact reach with levee behind

Below: Control reach looking upstream
